200 John Street & 588 Charlotte Street, Town of Niagara-on-the-Lake Cultural Heritage Evaluation Report

Heritage Planning Services
Leah Wallace, MA MCIP RPP

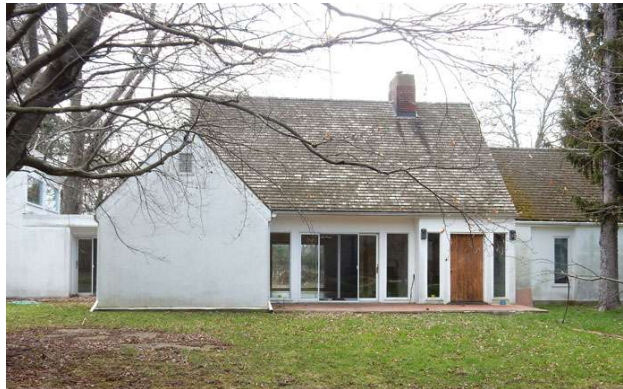
Figure 7: Calvin Rand House (Summer House) Facade, May 2018, LDW

The building is a one storey structure clad in a smooth white stucco finish and is set directly on a low concrete foundation. It consists of a more traditional central gable-roofed structure with several additional extensions to the rear and sides. These extensions have both flat roofs and unusual projecting half gables containing clerestory windows in the upper flat sections.

The house, formerly a guest house, was reconstructed in the 1970's by Calvin Rand and used as his summer home when he severed the property and moved from Randwood, which was then occupied by the Devonian Foundation. The reconstruction, carried out after a fire reputedly destroyed the original guest house, is in a contemporary style common for residential homes in the 1950's, 1960's and 1970's. John Blumenson describes this style as Contempo in his book Ontario Architecture: A Guide to Styles and Building Terms, 1784 to the Present, and describes features of this style as occasionally having innovative roof profiles with sweeping slopes and wing-like forms. Exterior finishes are monochromatic and vast expanses of glass in the form of floor to ceiling windows are common. Standard building materials such as stucco and brick combined with wood are also employed.⁴ Harold Kalman, in Volume 2 of his History of Canadian Architecture, states that prototypes of this style of architecture were developed in the first half of the 20th century by European architects. In Europe it was known as the 'International Style' which emphasized building materials rather than applied decoration. The use of this style in domestic architecture in Canada was pioneered by West Coast architects such as B.C. Binning and C.E. Pratt.⁵

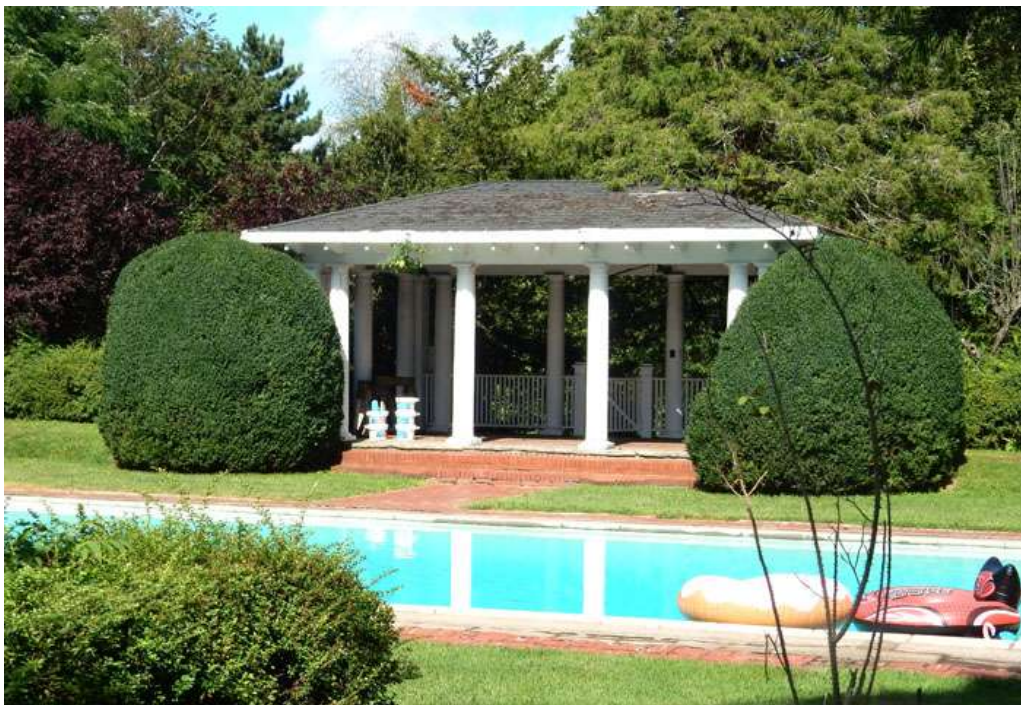
Figure 16: Tea House and Pool, August 2017, LDW

The tea house is located to the rear or west of the pool which fronts on the driveway. The structure sits on a raised platform of brick veneer. The hip roof has a deep overhang and exposed rafters in the Craftsman style. Simple Tuscan columns, coupled at the corners of the building, and a plain entablature support the roof structure. The interior ceiling of the pavilion is clad in tongue and groove boards that have been stained a deep brown. This is a common ceiling type for early 20th century porches and open garden structures. Stone and brick steps lead up to the structure and a picket fence is located to the rear. **(APPENDIX IV – Images 29, 30, 31, 32, 33)**

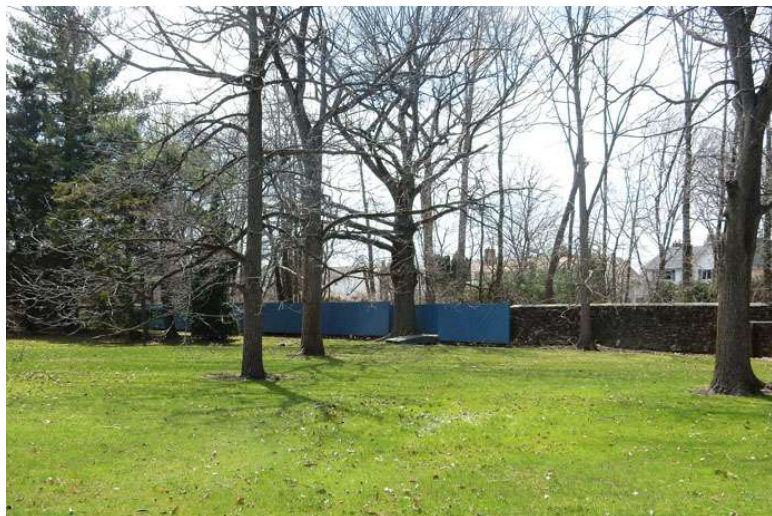
Figure 20: Wall with Collapsed Section, Before Tree Removal, May 2018, LDW

The entrance gates and the cobblestone and concrete wall, which continues along the railway trail from 200 John Street defines the eastern and southern boundaries of the property, though a large portion has collapsed and been replaced by an expanse of wooden wall which is not particularly compatible or appropriate in relation to the original wall and should be repaired and replaced to limit continued deterioration. (**APPENDIX IV – Images 70, 71**).

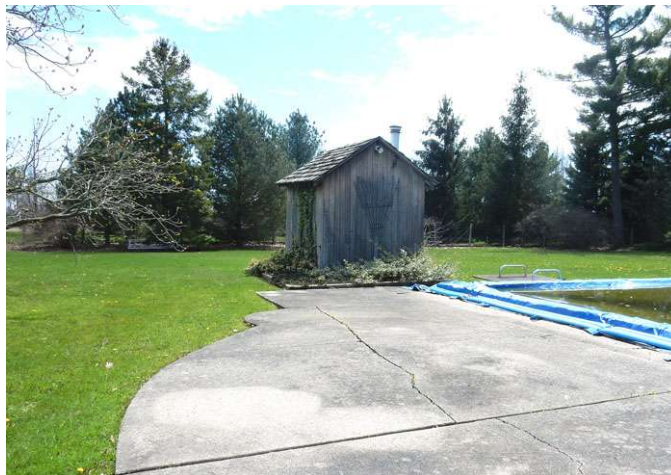
Figure 22: Pool House, May 2018, LDW

The in-ground pool is located in a flat open grassy area behind the house. It is surrounded by a concrete border or patio. There is a rustic pool house with a gable roof located adjacent to the west side of the pool. It is sided with unpainted barn board and houses the equipment required for maintenance of the pool. The pool house, pool and concrete surround are modern introductions into the landscape and were constructed by the previous owners.

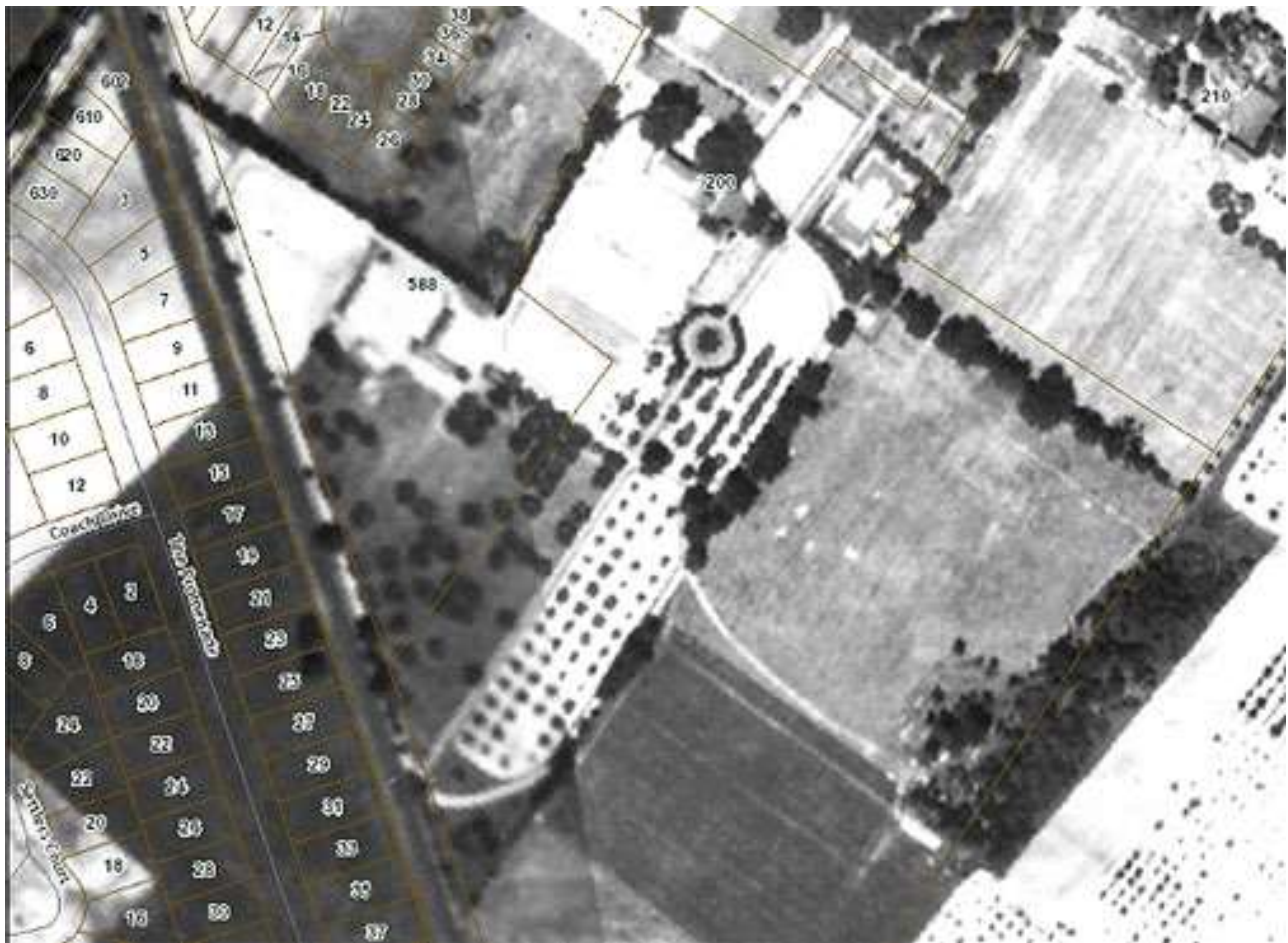
The 1934 aerial photograph shows the landscape shortly after the firm of Dunington-Grubb's documented designs for the Tea Pavilion and pool were constructed. The Tea Pavilion and Pool, and the associated pergola with surrounding formal plantings are clearly visible as are formal plantings to the north of this area. There also appears to be a path leading to what is now called the Bath House, though that building cannot be seen. The carriage house or garage is also visible as is the barn on 588 Charlotte Street, although only of the surrounding outbuildings that exist today is extant. Clearly a pathway runs south from behind the tea house and pool and intersects with a circular feature consisting of shrubs or trees. The pathway continues in a straight line south past an orchard to the opening in the wall at the whistle stop, though the pergola at the point is not visible.

Figure 28: 1934 Aerial Photograph, Niagara Navigator and Brock University Air Photo Index

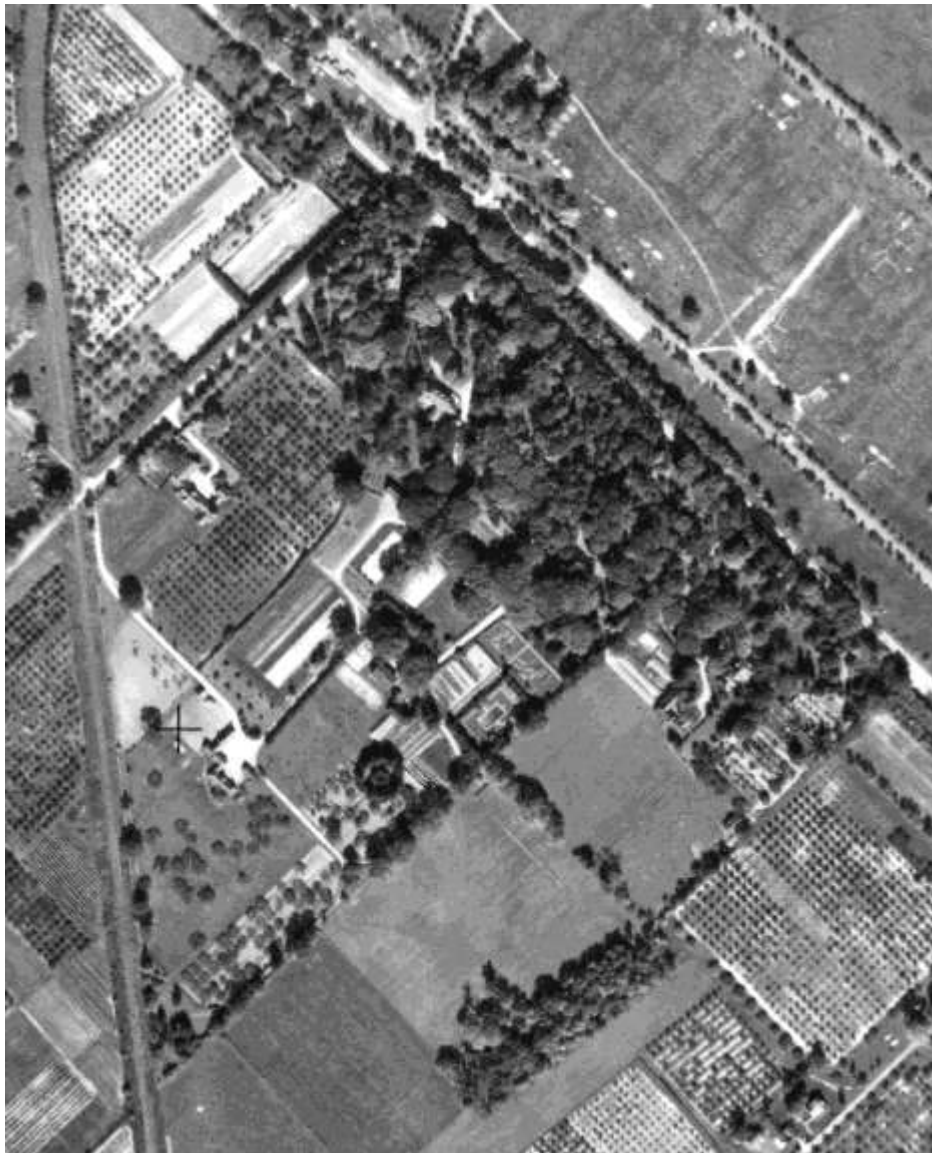
The 1953 aerial photograph clearly shows the pool and tea house area and the formal plantings to the north as well as the garage. However, the plantings related to the circular feature have grown and filled in. While the path from the tea house area still exists and still extends from the circular feature for a short distance to the south, it is now intersected at right angles by a new path that leads to the barn on 588 Charlotte Street which was converted to a residence in 1956. The path disappears to the south and some of the orchard trees have been removed. A new entrance, or driveway, has been constructed from Charlotte Street to the barn and the area that is now Christopher and Weatherstone Courts is planted in orchards.

Figure 29: 1953 Aerial Photograph, Brock University Air Photo Index

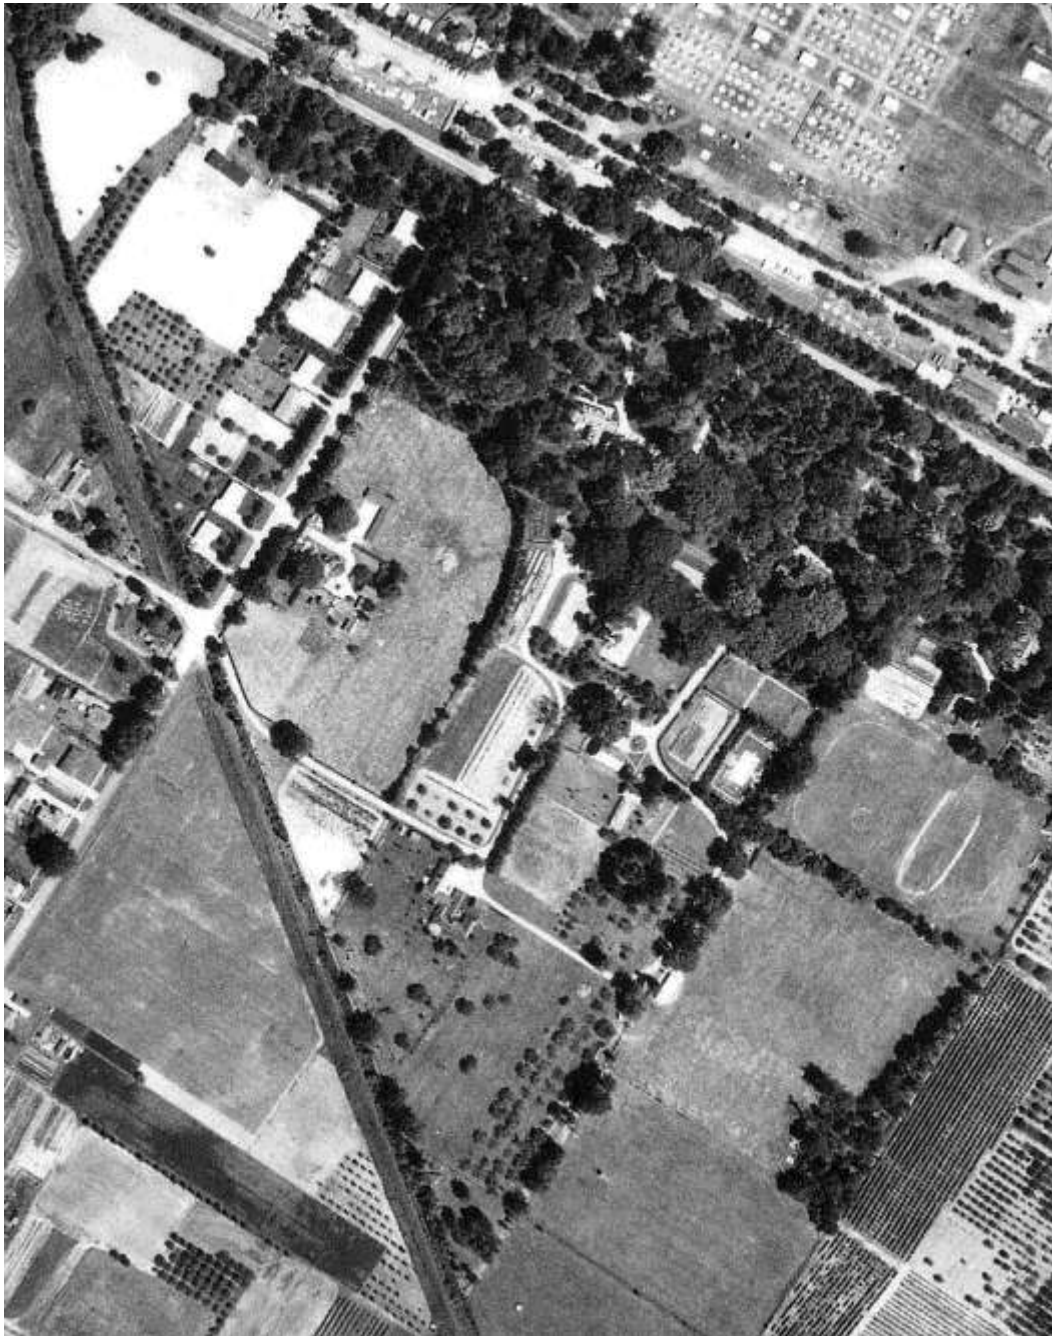
By 1965, while the tea house and pool and formal plantings are still discernible as is the circular feature, the path to the Whistle Stop to the south has disappeared.. The pergola at the Whistle Stop is visible and the barns at 588 Charlotte Street have assumed their u-shaped configuration. The buildings on 580 Charlotte Street and the Milk House and Stables are separate entities no longer connected to the estate as a whole. New pathways have been introduced from 176 John Street East to the pool area and other features in the landscape.

Figure 30: 1965 Aerial Photograph, Brock University Air Photo Index

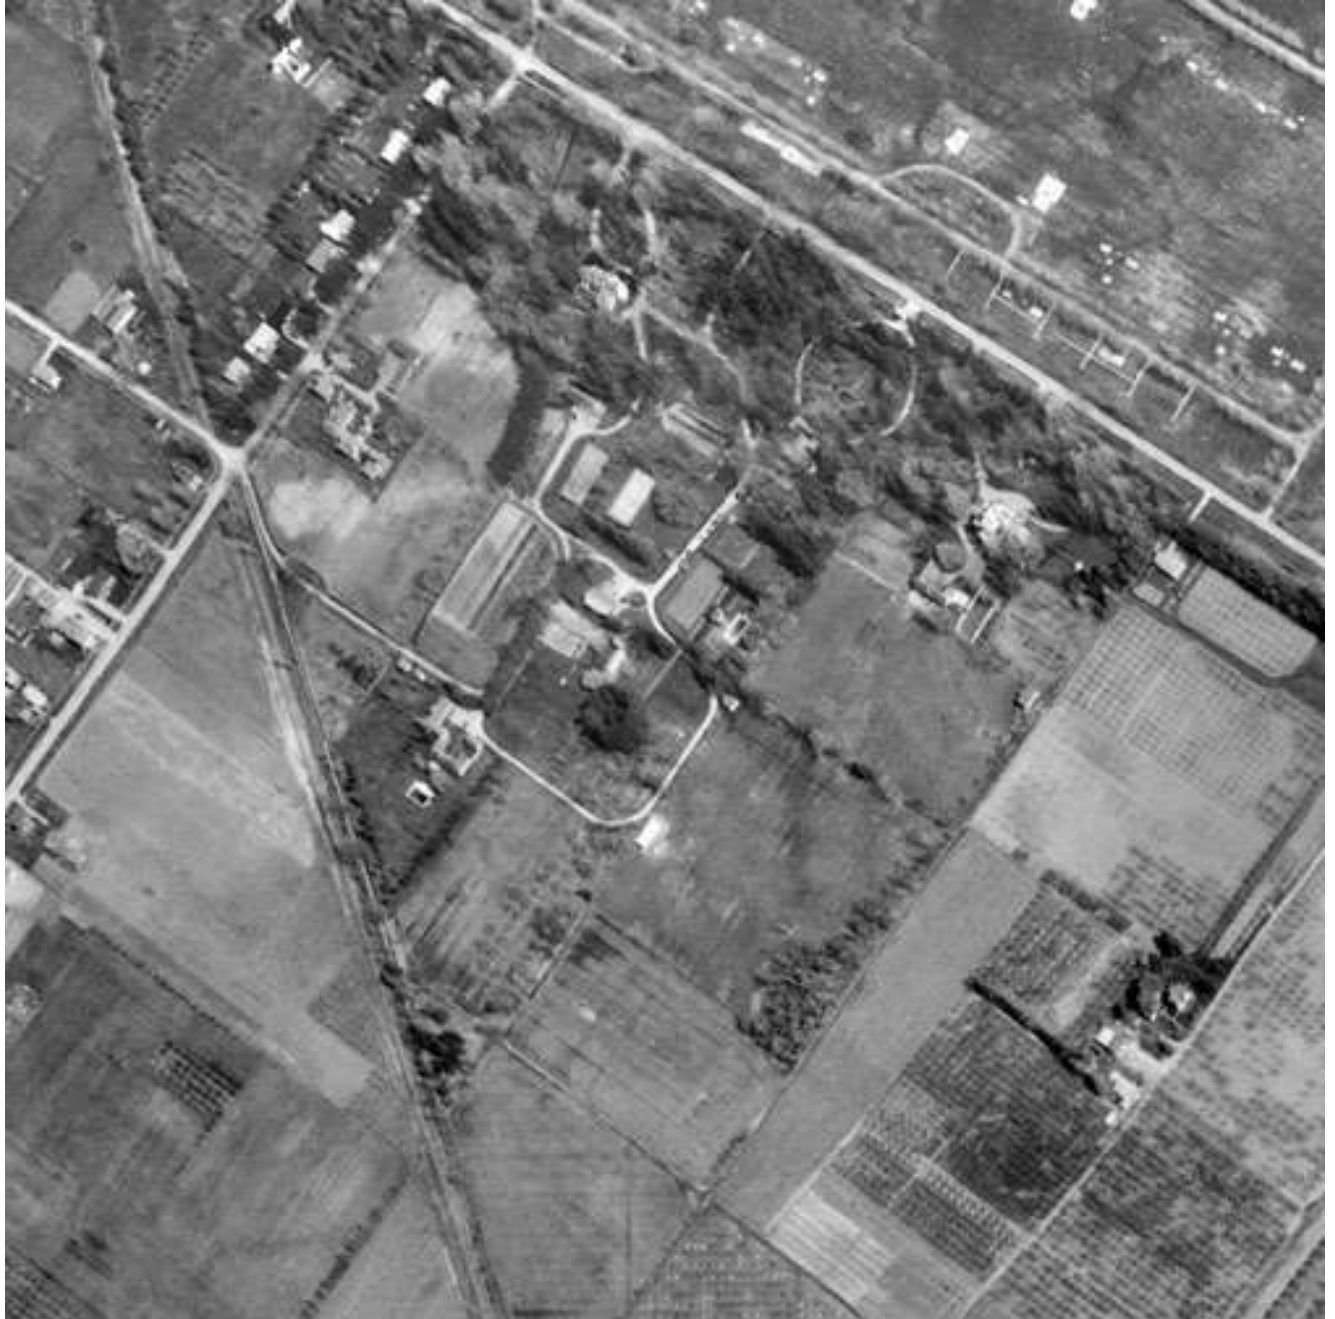
In 1972, additional circulation pathways have been introduced into the landscape, the circular feature is overgrown. The buildings on 588 Charlotte Street continue evolve and change and an in-ground pool is located to the rear of the main structure. The formal garden north of the pool area and any trace of the path to the Whistle Stop has disappeared.

Figure 31: 1972 Aerial Photograph, Brock University Air Photo Index

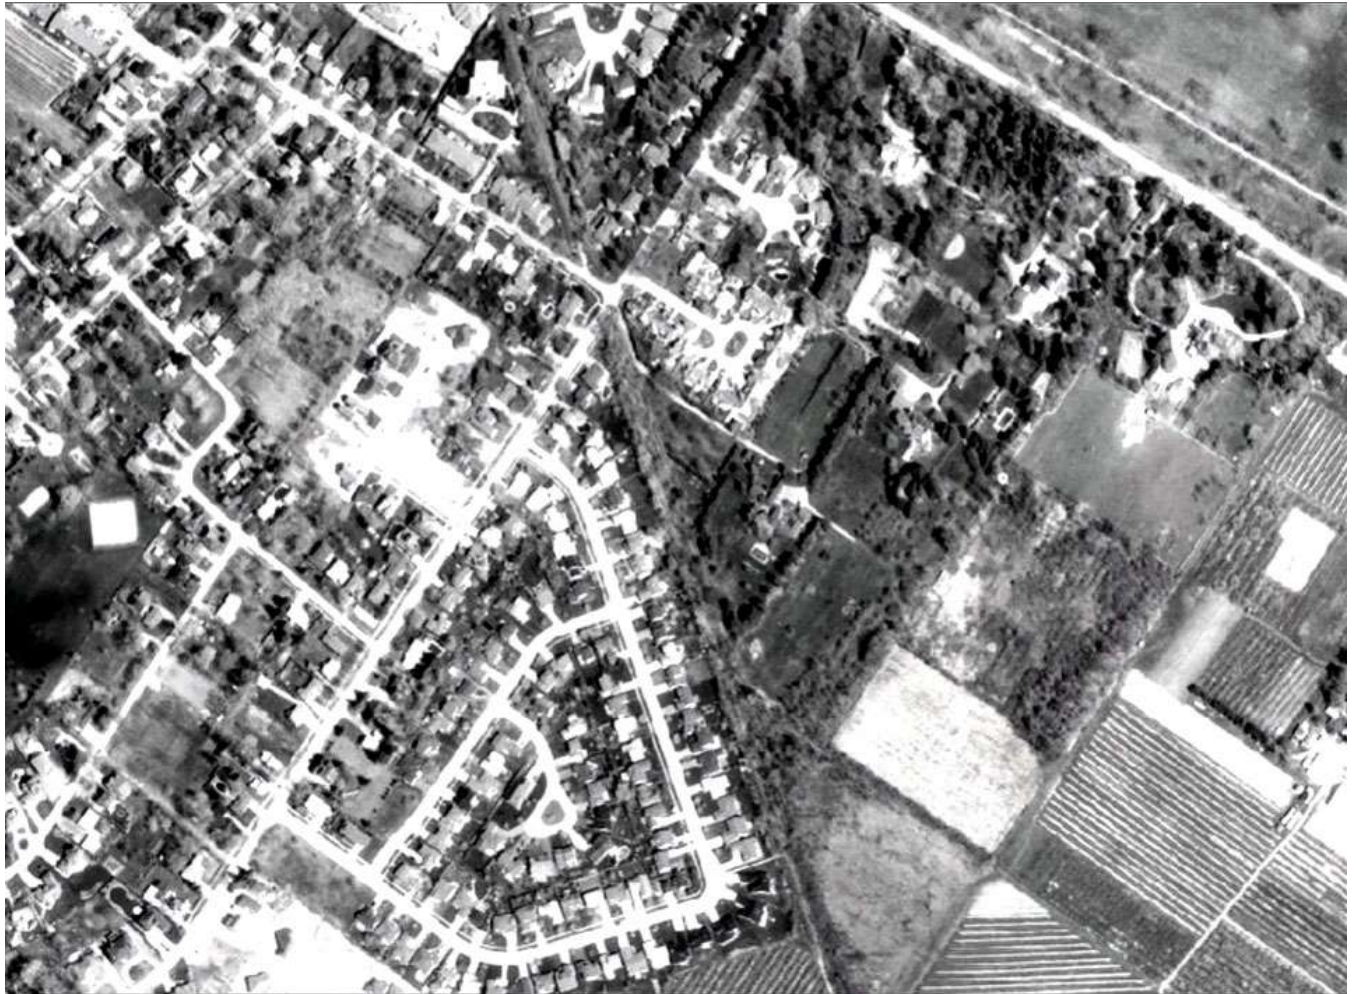
The 2000 aerial photograph illustrates the dramatic changes to the landscape. Weatherstone and Christopher Courts are developed and are no longer part of the Rand Estate. Though the circular feature is still discernible, the pathway does not exist and an open field extends from behind Calvin Rand's summer home to the south, terminating at the Railway Trail and the cobblestone and concrete wall.

Figure 32: 2000 Aerial Photograph, Brock University Air Photo Index

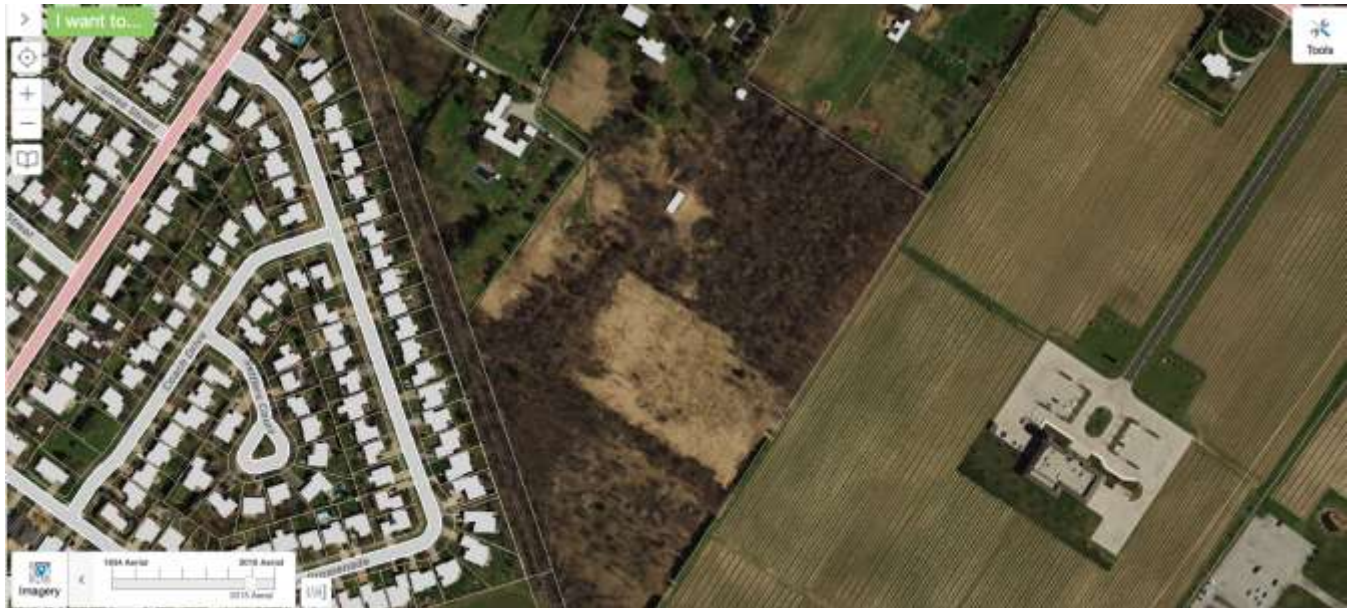
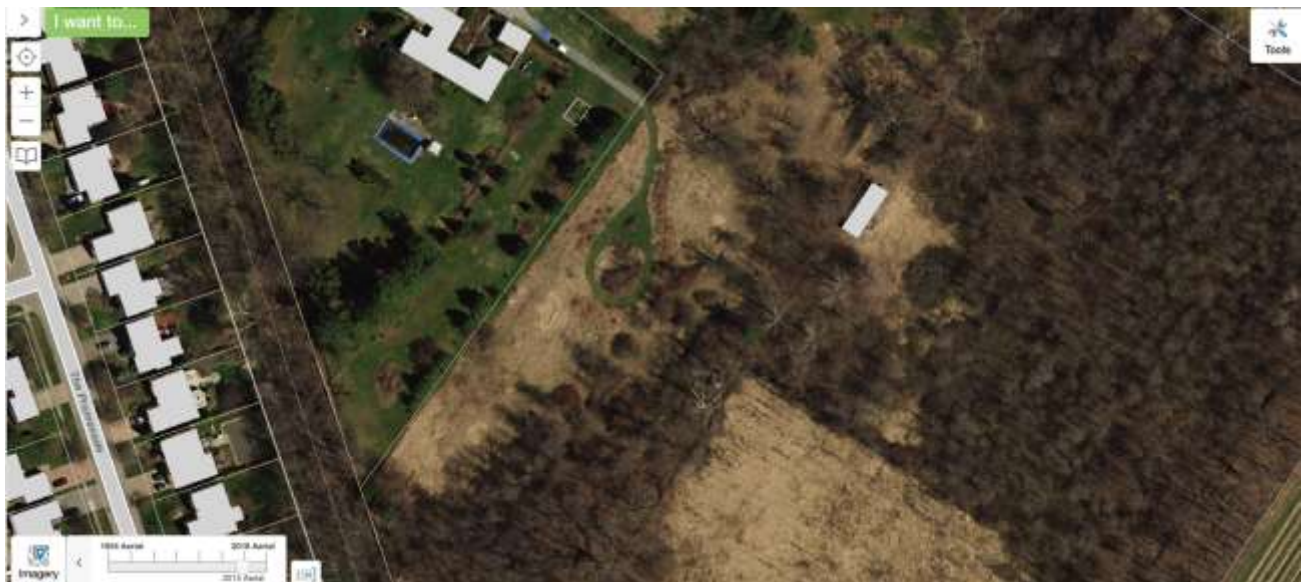
In a detail of the aerial photograph taken in 2015, it is clear that the owners of 588 Charlotte Street have created a new pathway in the shape of a tear drop extending from their property onto the property at 200 John Street and the circular feature is completely overgrown.

Figure 33: Details, 2015 Aerial Photograph Showing Tear Drop Pathway from 588 Charlotte Street to 200 John Street East, Niagara Navigator

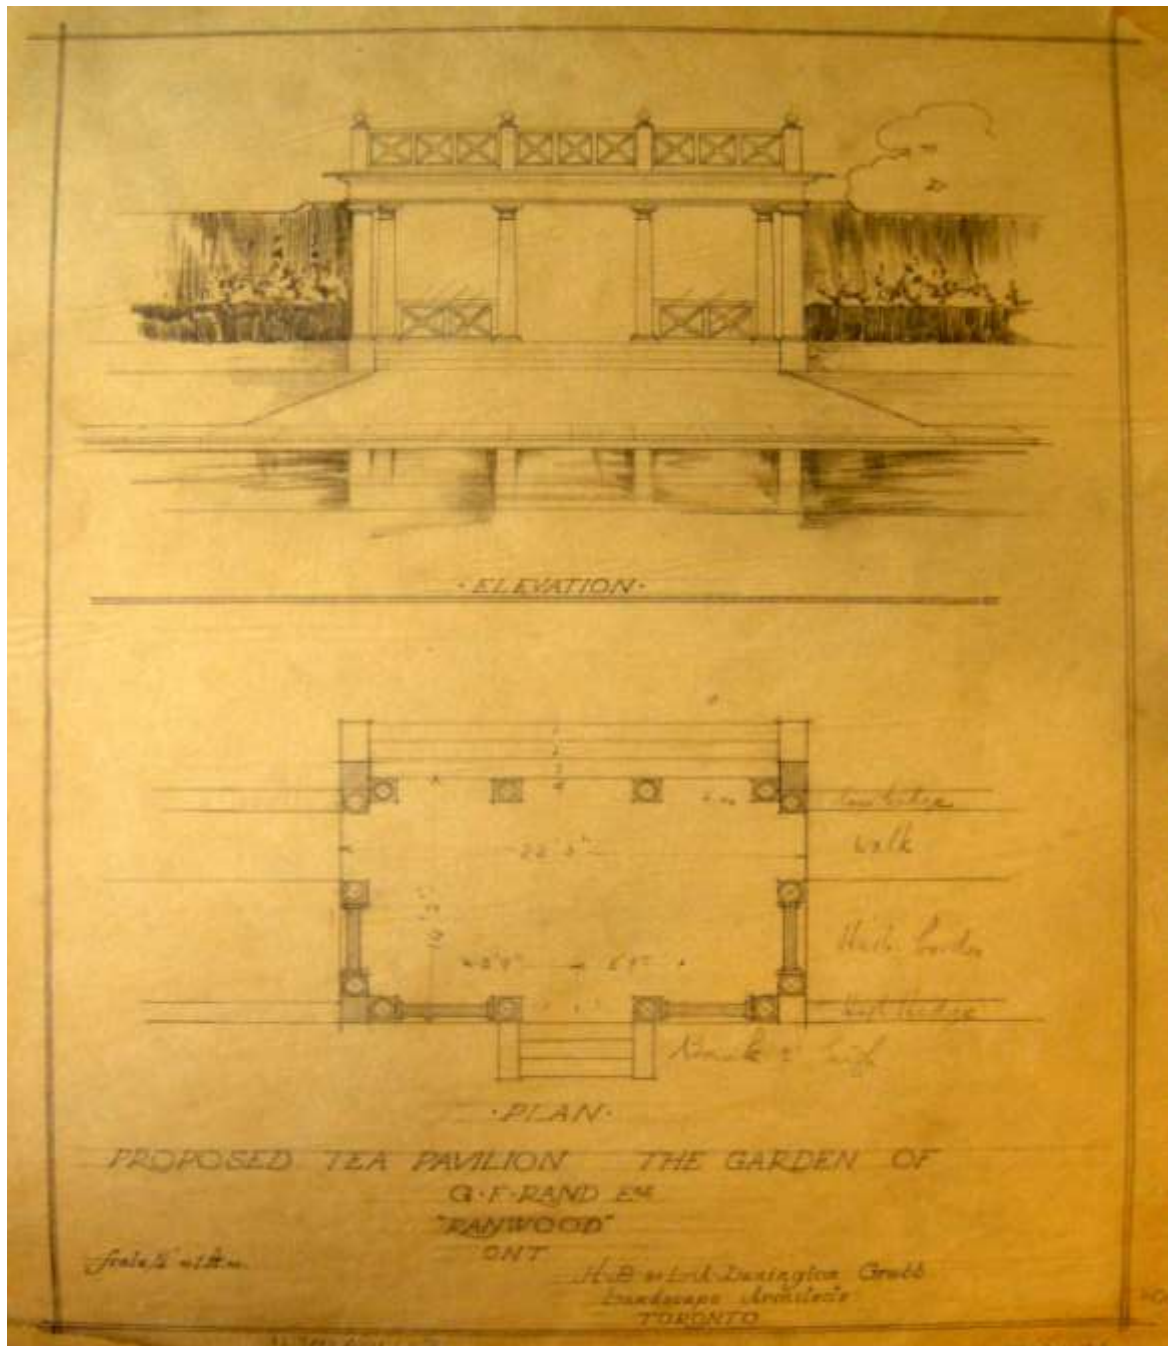
Drawing 4: Plan and Elevation of Tea Pavilion, April 1928, Dunington-Grubb and Stensson Fonds, Centre for Canadian Landscape Architecture Archives

The second design, dated April, 1928, accords closely with the remaining pool, tea house or pavilion, the surrounding plantings, some of the herbaceous borders, the grass banks and the concrete bases that are probably the bases for the pergola columns which do not survive; but which are noted on the plan. Two iterations of the tea pavilion, including plans and elevations, survive though the existing pavilion differs in detail from both of these iterations. Unfortunately, no detailed drawings for the pergola exist. Other landscape features, such as the formal planting beds of roses are no longer extant or are overgrown and difficult to discern. **(APPENDIX III – Drawings 4, 5, 6)**

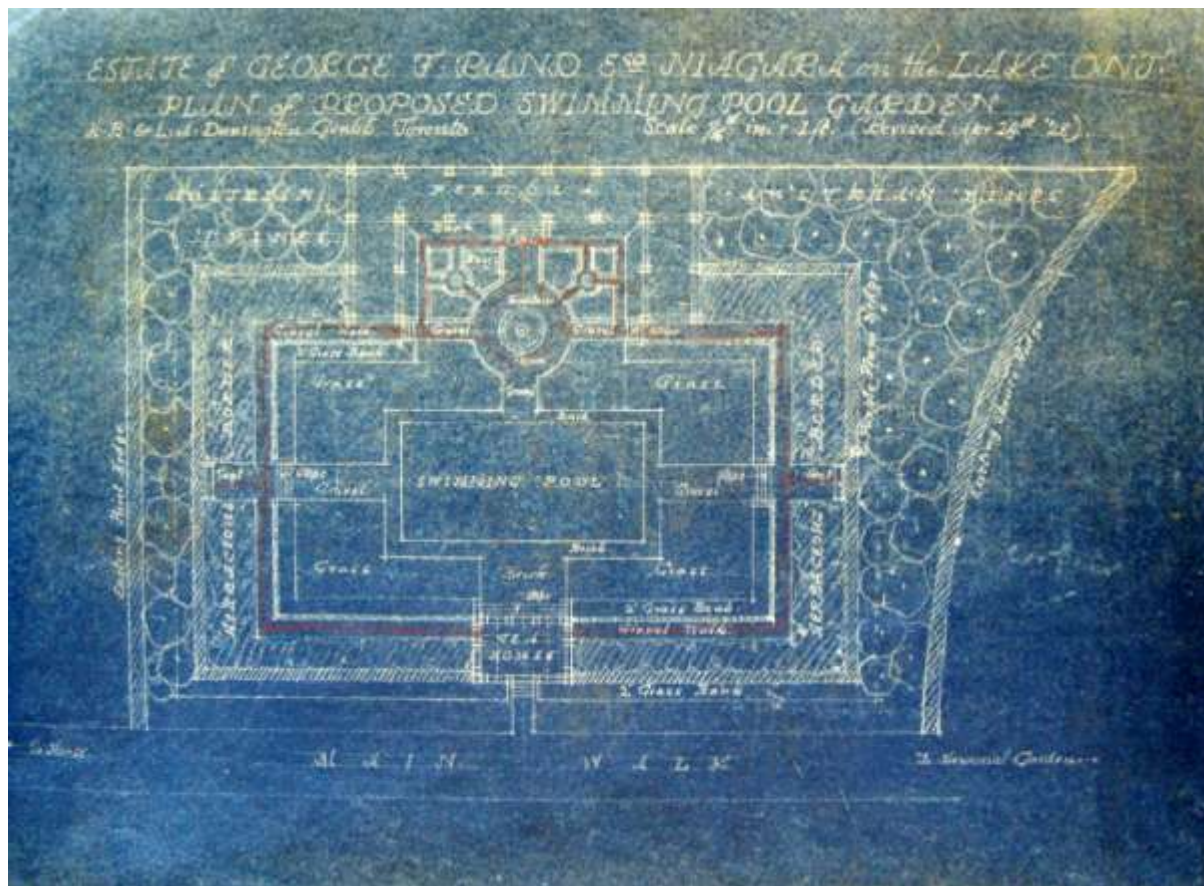
Drawing 6: Plan for Tea House and Pool with Proposed Planting Plan, Blueprint, Date Unkown, Dunington-Grubb and Stensson Fonds, Centre for Canadian Landscape Architecture Archives

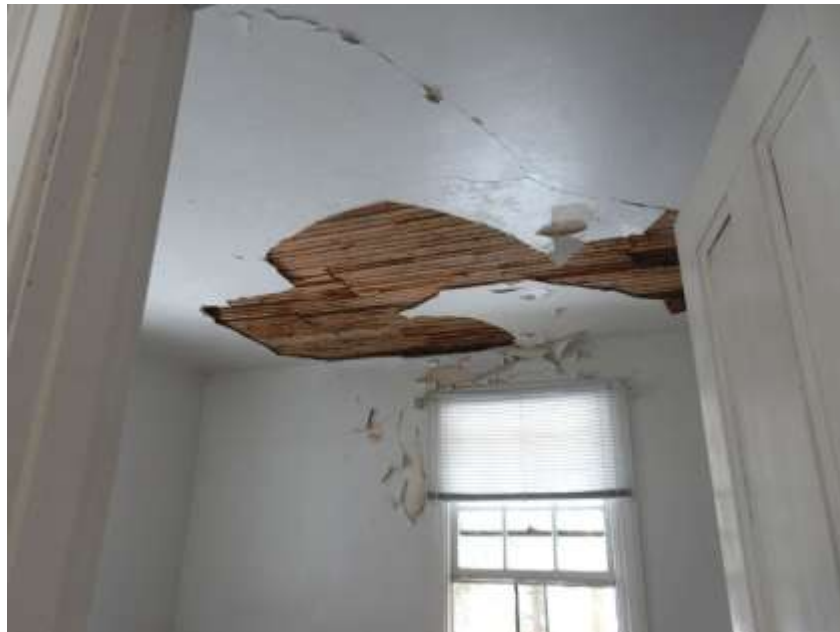
Image 26: Carriage House Apartment, Ceiling Damage, March 6, 2018

When the garage was first viewed in August 2017, before it was acquired by the present owner it was in a deteriorated condition. When viewed again in March 2018, it had not been altered and, though it had not deteriorated any further, it continued to be in poor condition.

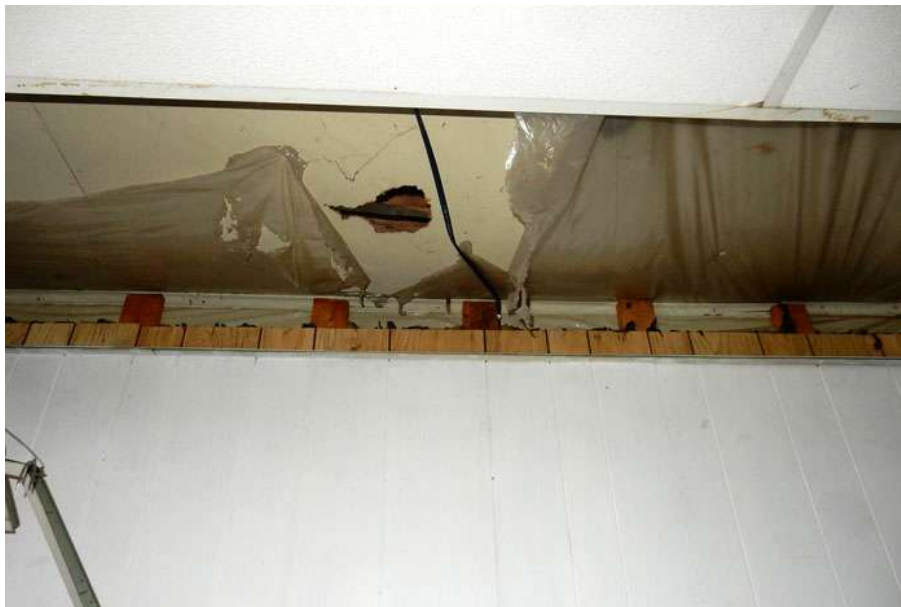
Image 28: Carriage House Apartment Bedroom, Ceiling Damage, March 6, 2018

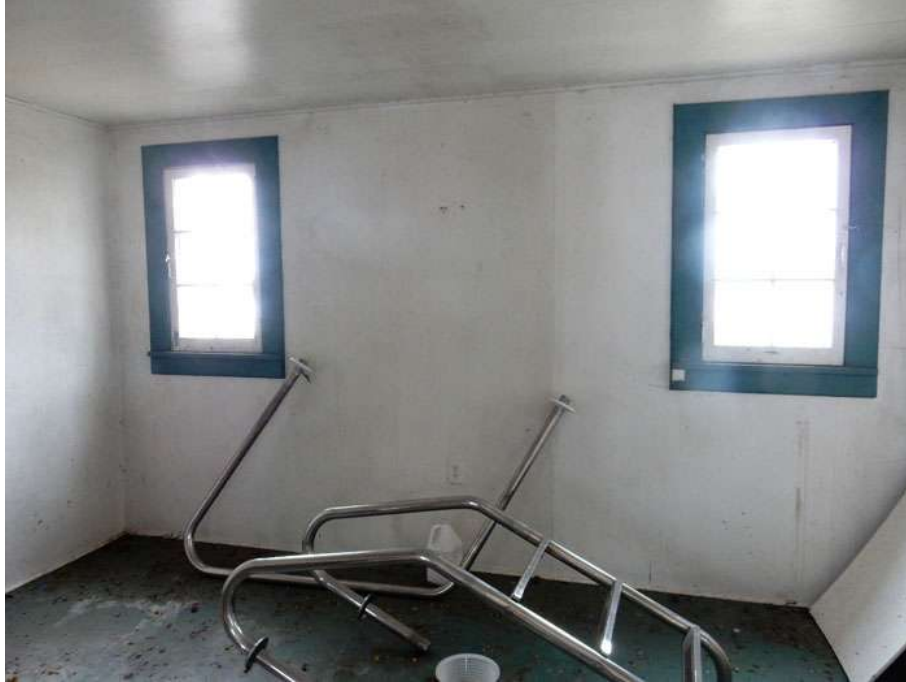
Image 41: Bath House Interior, March 6, 2018

The interior of the pool house is a simple space with plastered walls and ceiling which is collapsing. It contains a rudimentary kitchen located in an alcove and a bathroom with a modern shower stall. At some point it appears to have been used for human habitation. However, the interior has no significant architectural features. The building is in a state of decay with rotting wood at the base and on the columns and collapsing ceilings and floors. It will require extensive restoration. However, it is a building with a great deal of charm and could be an asset to the landscape. **(APPENDIX IV - Images 41, 42, 43)**

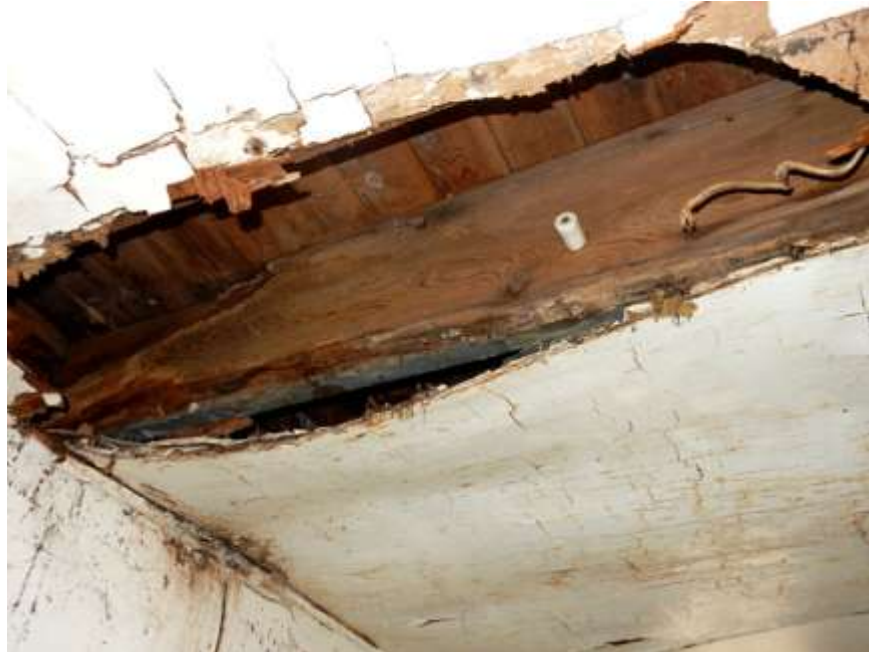
Image 43: Bath House Ceiling Damage, March 6, 2018

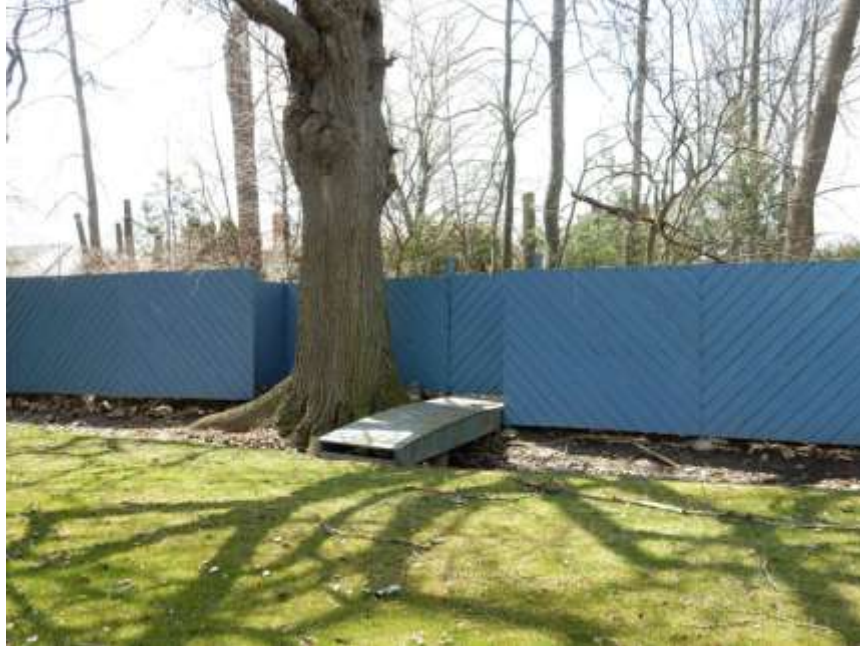
Image 72: 588 Charlotte Street, Wooden Replacement Wall, May 1, 2018

There are no clearly discernible designed landscape features on the site with the exception of the stone wall that runs behind the property bordering the railway trail. The wall in this area is in poor condition with gaps where it has collapsed and been replaced by wooden fencing by the previous owners.
